BOLETÍN DE LA SOCIEDAD GEOLÓGICA MEXICANA VOLUMEN 65, NÚM. 1, 2013, P. 169-188

Active sinking at the bottom of the Rincón de Parangueo Maar (Guanajuato, México) and its probable relation with subsidence faults at Salamanca and Celaya

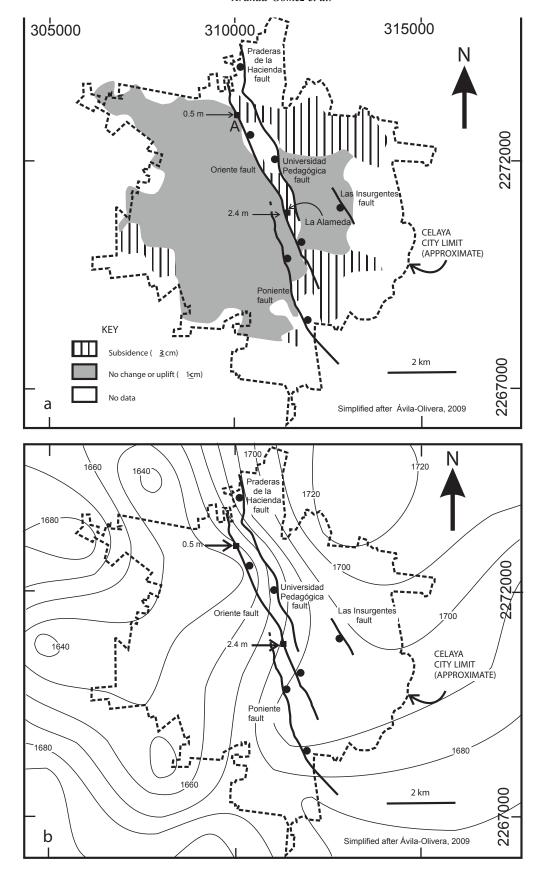
Figure 6. a) Land subsidence in Celaya as inferred by Ávila-Olivera (2009) and Ávila-Olivera *et al.* (2010) from InSAR data in the period 11/02/06 – 27/05/06. b) The same figure, showing piezometric isolines (elevation given in meters above sea level) in 2007. Subsidence-related faults coincide with the boundary between two domains in the piezometric surface; east of the faults the surface is shallower (Ávila-Olivera, 2009).

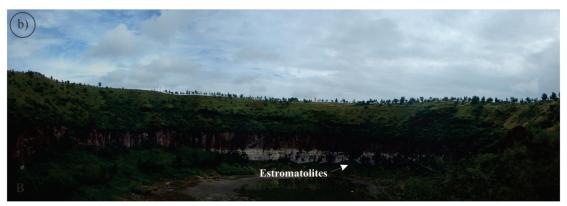
no longer a permanent lake inside the crater (Figure 8b, 8c) as a consequence of overdraft in the aquifer; the maximum level the lake attained in the recent past is clearly marked with salts on the walls of the crater (Figure 8b). Based on the height difference between the mark on the wall and the bottom of the dry lake bed and the date when the crater was desiccated, Escolero-Fuentes and Alcocer-Durand (2004) estimated a drawdown rate for the Valle de Santiago – Salamanca aquifer of 2.6 m/year.

Figure 8. Panoramic views of La Alberca crater. a) The northern wall prior to desiccation process (date when photograph was taken is unknown, but probably before 1985. This photograph is sold as a postcard in Valle de Santiago). b) Approximately the same view, as seen in August 2010. Note that the small "playa-lake" has a slight red color, probably due to the presence of cyanobacteria in the water. c) Line drawing enhancing the main features shown in (b).

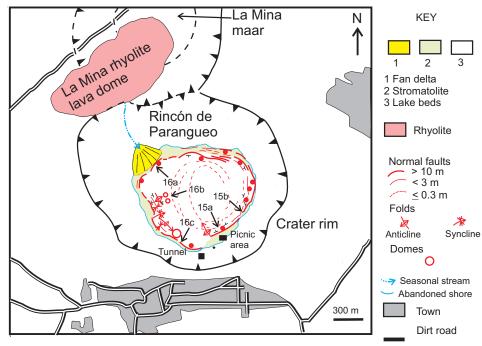
Figure 14. Structural sketch map of the bottom of the crater at Rincón de Parangueo and location of figures 15 and 16 (shown with arrows). Location of inferred faults or dissolution mini-scarps (?) in the "active" part of the lake at the deepest part of the crater, near present day depocenter, is highly uncertain.

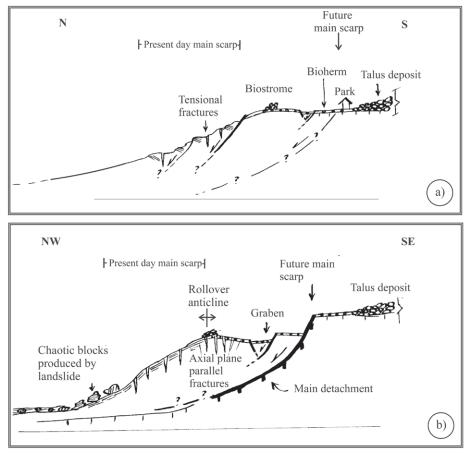
Figure 15 Schematic cross sections (no scale) displaying the main structural features discussed in the text. a) Near the picnic area inside the crater. b) Near the main fault scarp, about 200 m NE of the picnic area. Both sections display the characteristic deformation style observed in the eastern part of the former lake bed.

A strikingly different deformation style, as compared to the roll-over seen in the SE portion of the ring fault (Figure 15b), is exposed on the western part of the former lake. At

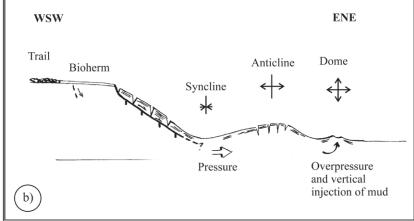
the other hand, there is also a hint of a highly asymmetric anticline parallel to the topographic scarp, which has a gently tilted limb on the northern side and a steep limb in the southern side (Figure 16a). At the top of the scarp the sedimentary succession is a gently tilted surface formed by a stromatolite biostrome and well developed bioherms. Right at the edge of the platform, the tilt angle increases. We found an open fracture that suggests that in the near future the scarp wall will collapse as a topple (Figue 16a).

Figure 16. Schematic cross sections on the western part of the ring fault (see Figure 14 for locations of a, b, and c). No scale. Note the marked difference between figure 16b and 15b.

this site (20° 25.868'N, 101° 15.216'W) it seems that large blocks are sliding along a flat surface tilted towards the depocenter (Figure 16b). Widely opened, curved tensional fractures are remarkable in this area. At the base of this structural feature there is no landslide deposit (i.e. randomly oriented megablocks). It appears as if the weight of the mass that is moving downward produces a syncline – anticline couple. Farther towards the ENE small domes, about 1 m high, are exposed. If the elongated hill that is shown as an anticline in Figure 16b is followed along the trace of the axial plane, it may be observed that the "anticline" is formed by a string of at least three domes (alternatively, the anticline may have an undulated axis). Tensional fractures are conspicuous at the top of the string of domes. We speculate that these structures, the "anticline" and domes, may have been formed by mud injection.
