This is a pre-print of an article published in *Landslides*. The final authenticated version is available online at: [10.1007/s10346-018-1031-z](https://doi.org/10.1007/s10346-018-1031-z)

Deep-seated gravitational slope deformations triggered by extreme rainfall and agricultural practices (eastern Michoacan, Mexico)

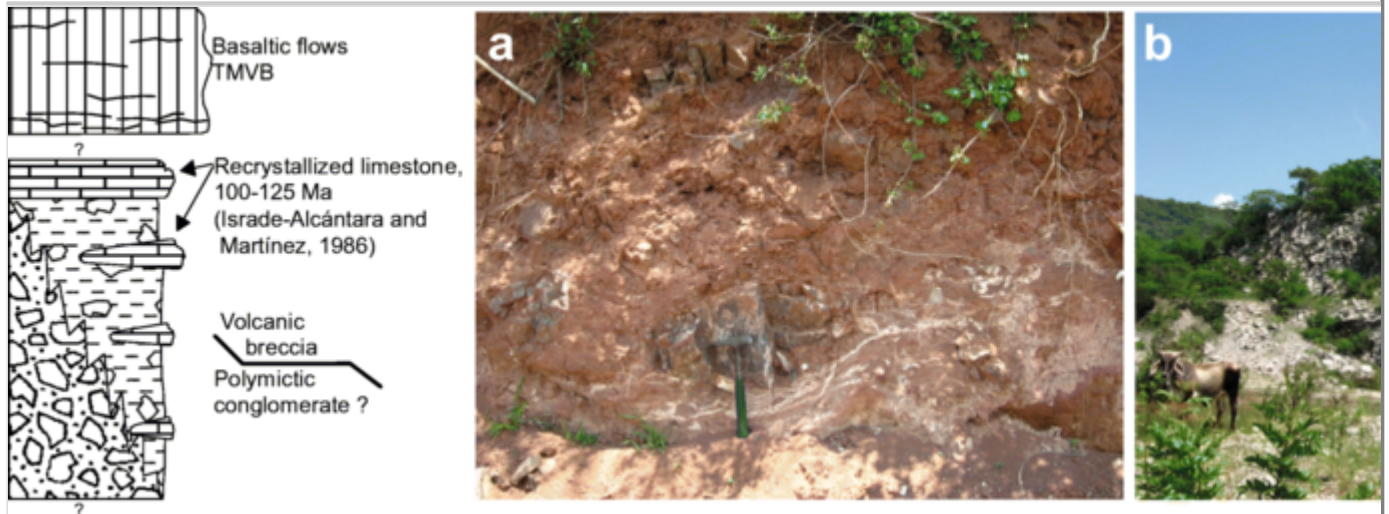
Fig. 5

Schematic stratigraphic column of the Las Pilas area, showing conglomerate overlain by recrystallized limestone. The top of the sequence is formed by Miocene and

Pleistocene basaltic lavas. (a) Highly altered volcanic breccia and (b) limestone bank

In the Las Pilas area, four lithostratigraphic units were also identified (Figs. 2 and 5). Their details are presented, from base to top, as follows:

Volcanic breccia This unit consists of sub-angular clasts of porphyritic andesite up to 30 cm long immersed in a matrix of reddish clay-fine sand (Fig. 5(a)). The Las Pilas affected area is emplaced within this unit.

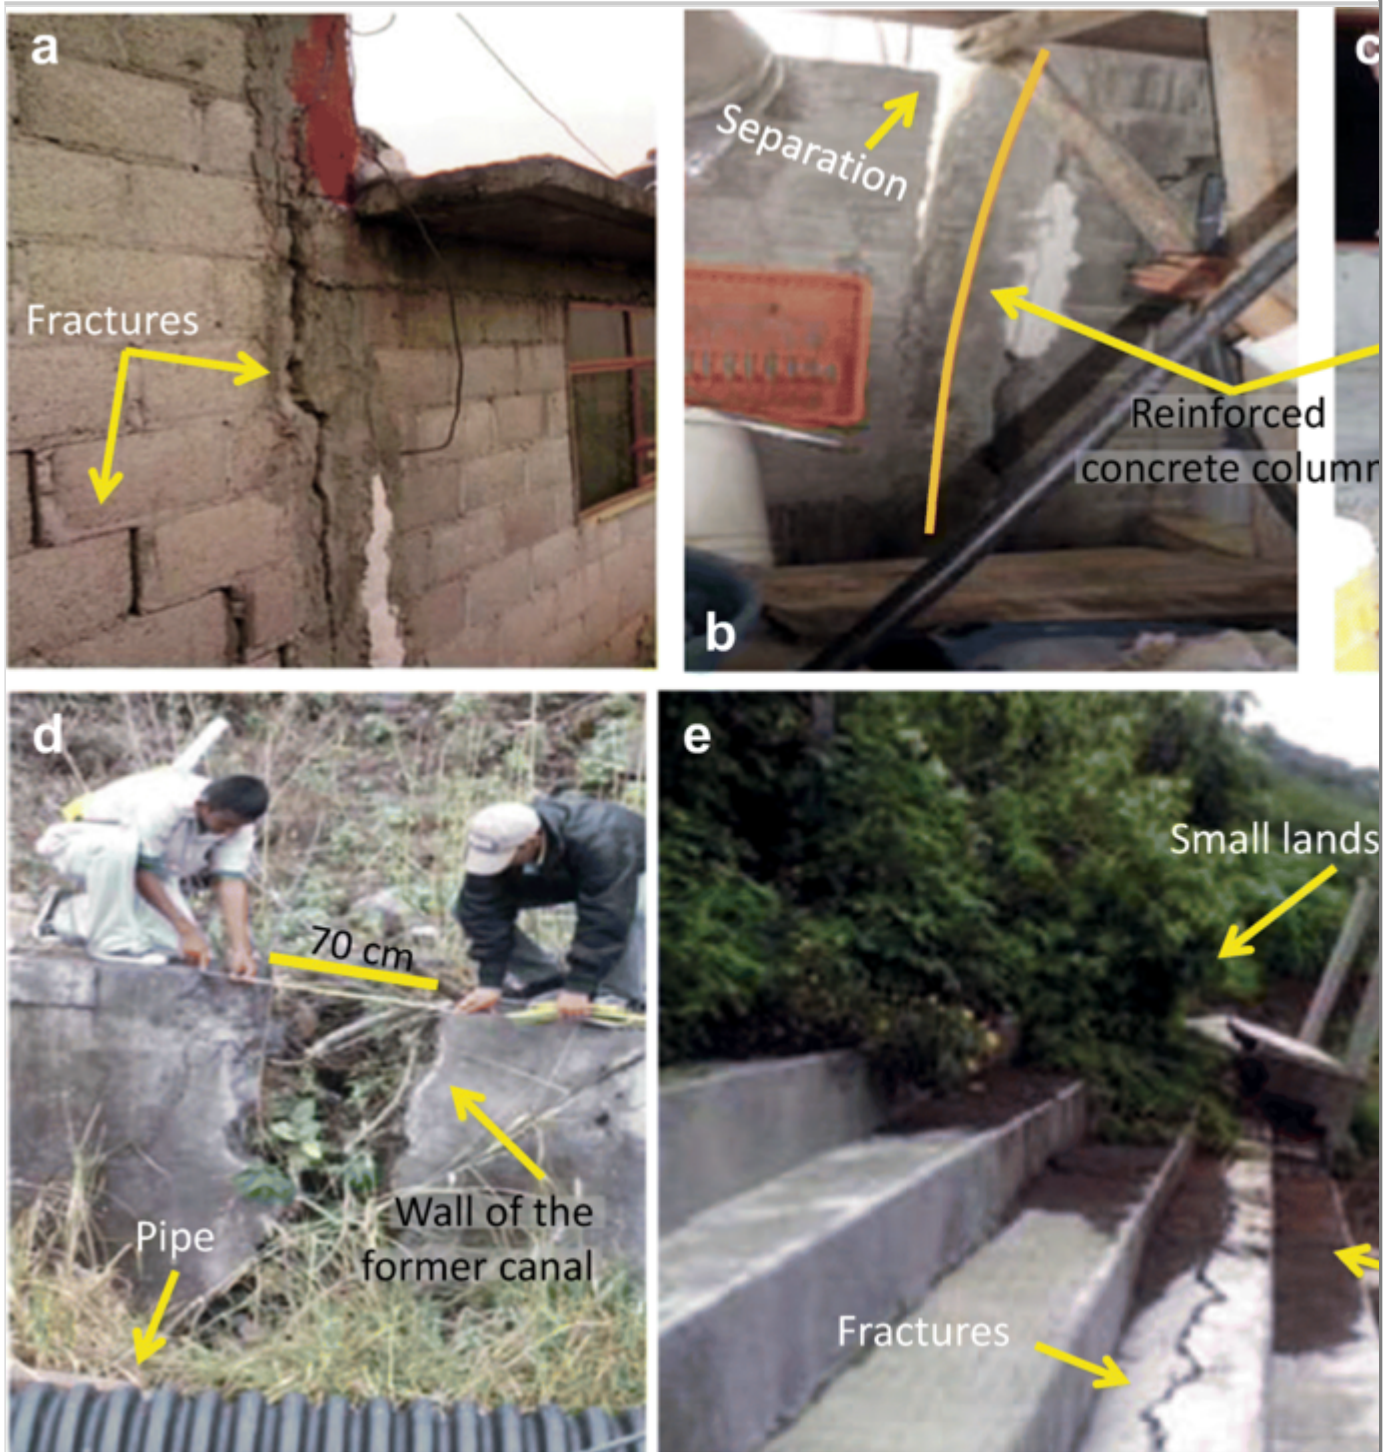
Fig. 11

Damage in diverse buildings of Las Pilas village registered in 2012. (a) Vertical and 45° fractures caused by differential movement. (b) Flexion of reinforced column triggering fractures and separation within the wall. (c) Flexion and fractures at 45° in a reinforced column. (d) Separation of at least 70 cm in the wall of the former canal. (e) Small secondary landslide, earth flow, and fractures affecting part of the local church

(Fig. 11(d)). After the 2010 rainfall occurrence, the movement, which was either in a dormant state or almost imperceptible, began to accelerate. In 2012, a census in the locality revealed that 28 of the 50 house buildings had significant structural damage (Fig. 11). Moreover, the lower part of the slope is covered by chayote and guava crops (7.9 Ha) that have a flood-irrigation system.

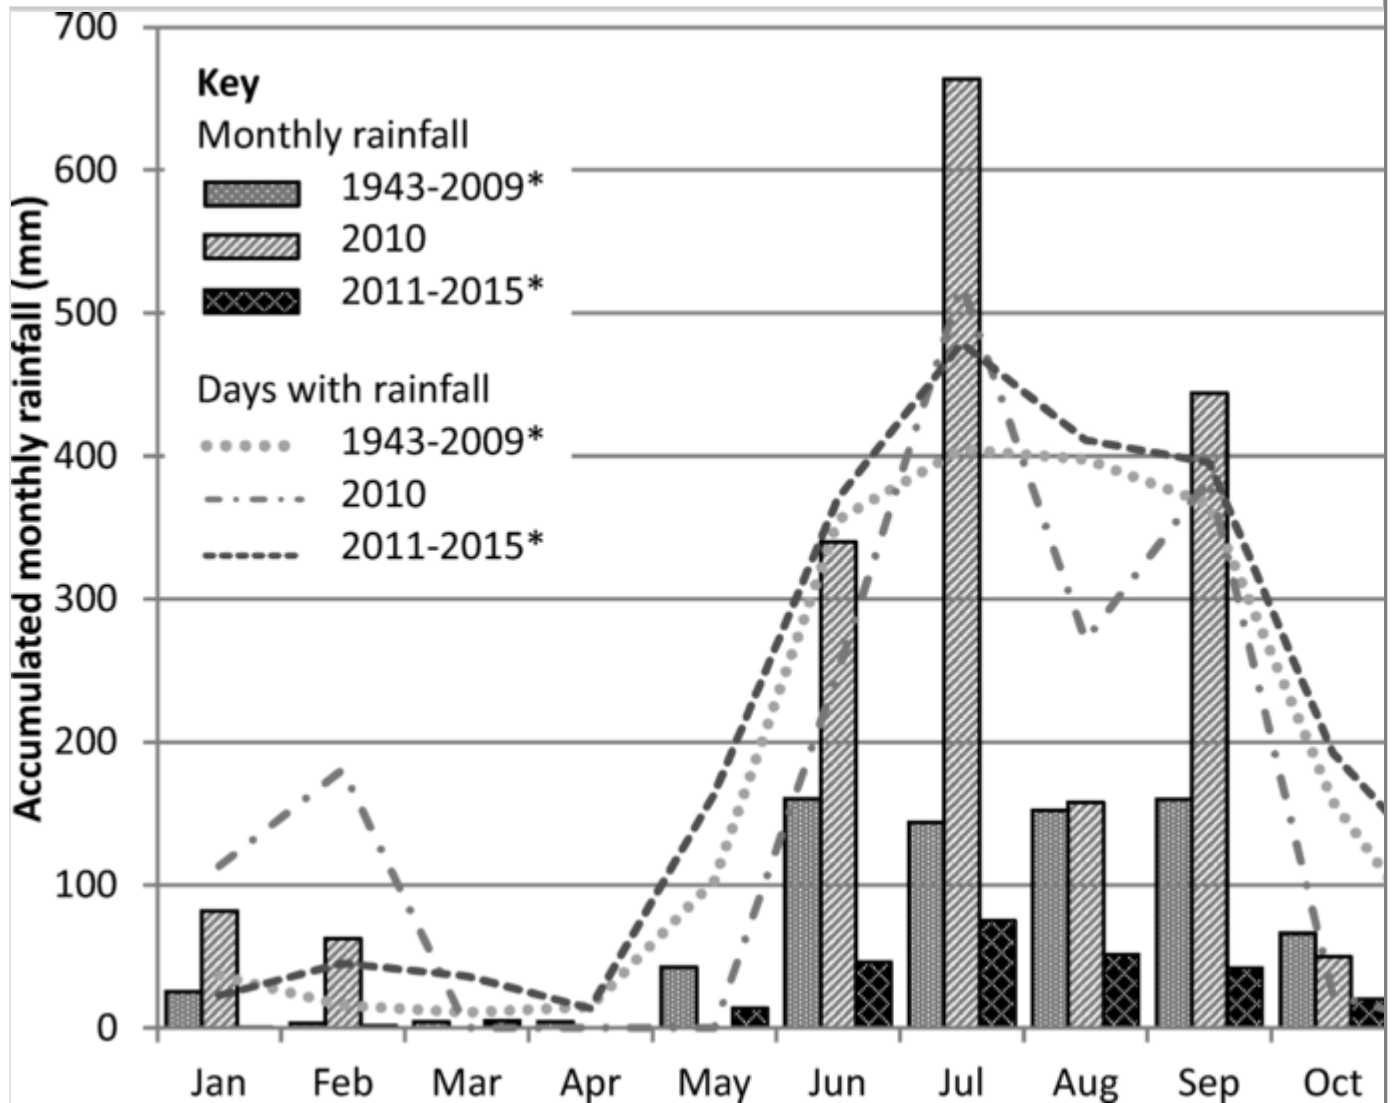
Fig. 14

Accumulated monthly rainfall behavior in station number 16058 of CONAGUA. The asterisk (*) indicates average

The Jungapeo region has a tropical climate, normally with rainfall during June to September that ranges from 800 to 1300 mm annually and minor rainfall in autumn and winter (Fig. 14; INEGI 2009). For the periods of 1943–2009 and 2011–2015, the rainy season had a frequency of up to 15 days/month with a uniform amount of accumulated rain. Thereafter, the autumn was characterized by a gradual decrease in frequency and amount of rain. In winter, the record indicates a frequency of 1 to 2 days/month. However, January is the month with the highest accumulated rain of this season, while in February and March, it is almost non-existent.

In comparison, what characterized 2010 was the combination of atypical January and February rainfall (82 and 63 mm, respectively) brought on by two cold fronts that interacted with the jet stream and other climatic phenomena (Aguilar-Garduño et al. 2010). Of the total number of years analyzed, the only ones that exceed this amount of rainfall in January are 1967 and 1980, with 118 and 163 mm, respectively. However, the February rainfall has no historical comparison. The highest peak recorded was 28 mm in 1968, almost half of the estimate for 2010. On the other hand, the rainy season (excepting August) also presented accumulated values above the average. The months of June, July, and September represent an increase of 112, 362, and 177% with respect to the period of 1943–2009.
